Vendor's building survey report

## Twenty Old Bailey, London EC4M 7AN

Prepared for: Hines UK Ltd  
Prepared by: Simon Devlin BSc (Hons) MRICS  
Viki Tsoutsas MEng MSc  
Issue date: 03 June 2026  
Report stage: Draft  
Reference: 133500-100

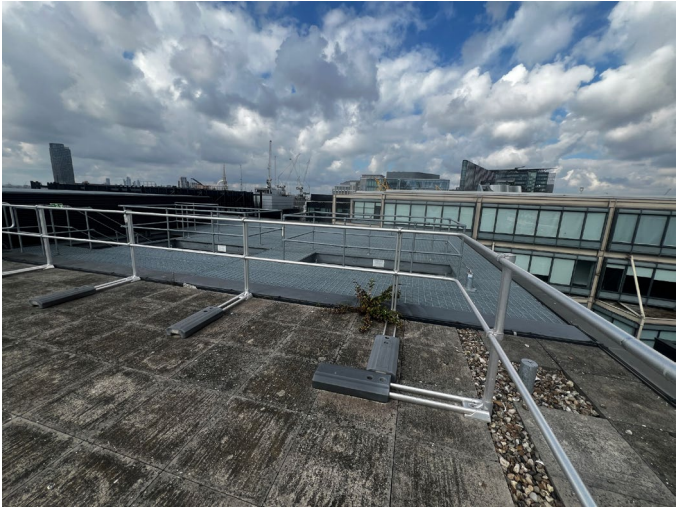
| 3. | Vegetation to roof areas should be regularly removed to prevent blockages and damage. | |

- At the time of inspection, no water leaks were reported or immediately apparent.
- The main roof located at 8<sup>th</sup> floor and 9<sup>th</sup> floor is an inverted roof that dates from the 2017 refurbishment, therefore we would not envisage any works over and above routine maintenance. This would include removing vegetation and replacing broken paving slabs.

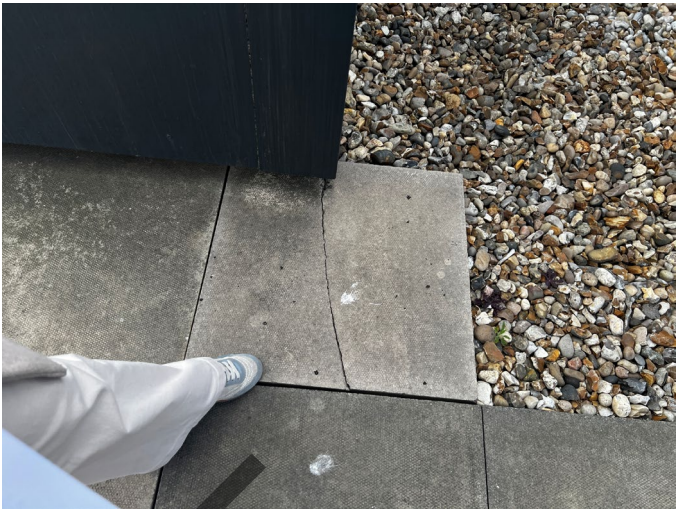
| 4. | Cracked paving slab to man roof which can become a trip hazard. | |

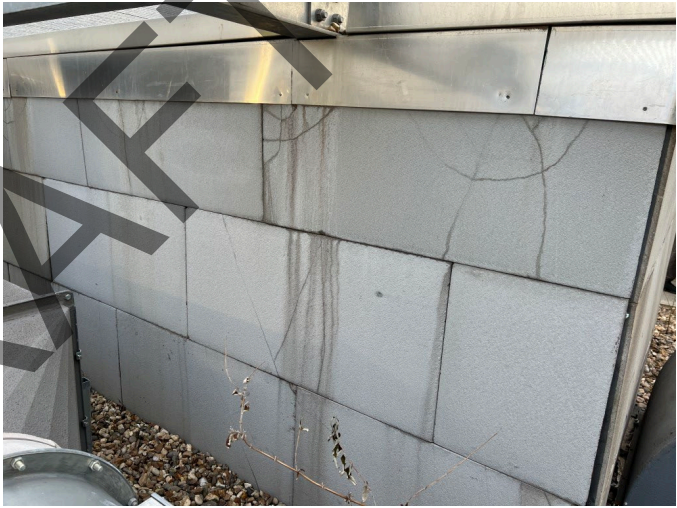
- There is cracking to the fibre cement boards lining the plant rooms at roof level; presumably from impact damage. This is aesthetic only.

| 5. | Cracking to fibre cement boards to plant enclosures, main roof. | |

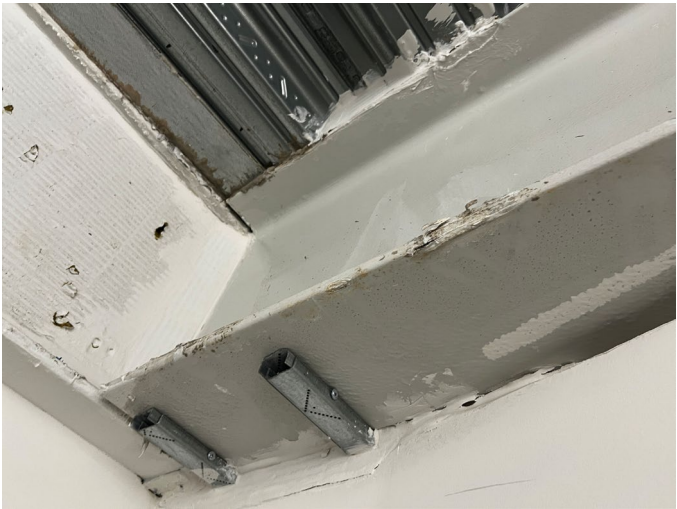
| 6. | Evidence of deterioration to intumescent coating to plant room areas. | |

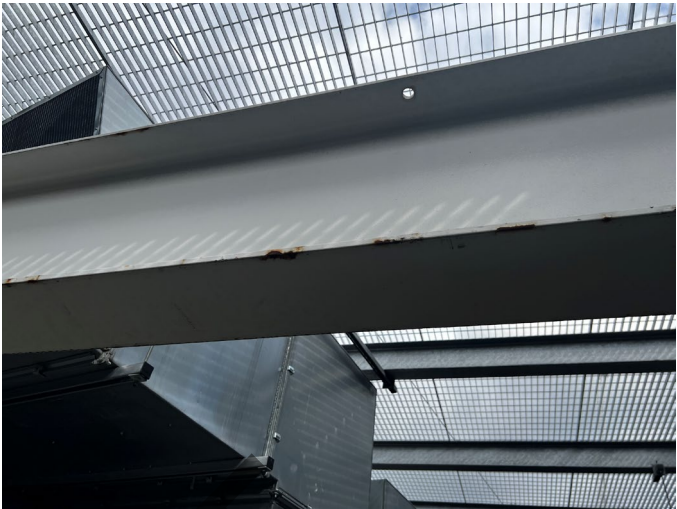
| 7. | Evidence of deterioration to intumescent coating to external plant room areas. | |

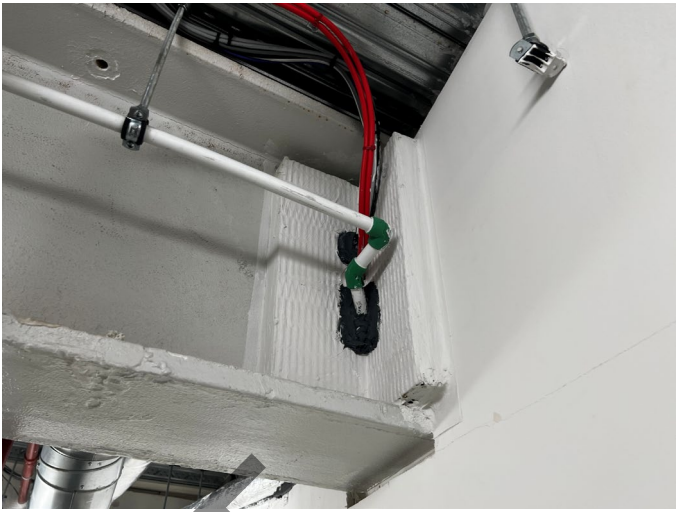
| 10. | Retrospective, unlabelled fire stopping to roof level plant room. | |

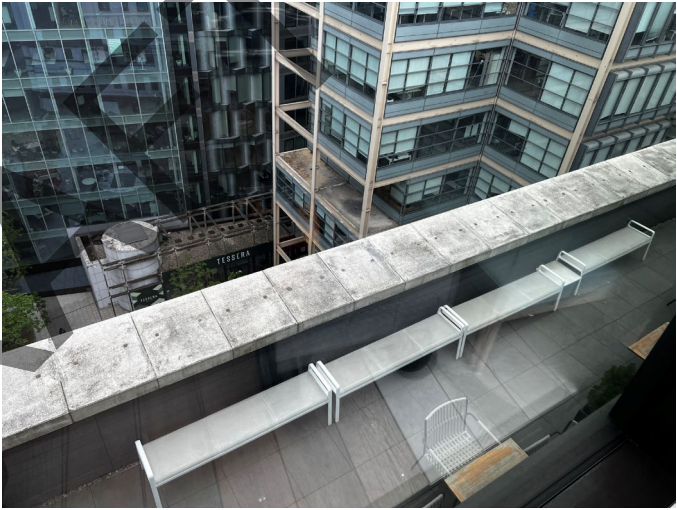
| 11. | Soiling to copings, 8 <sup>th</sup> floor. | |

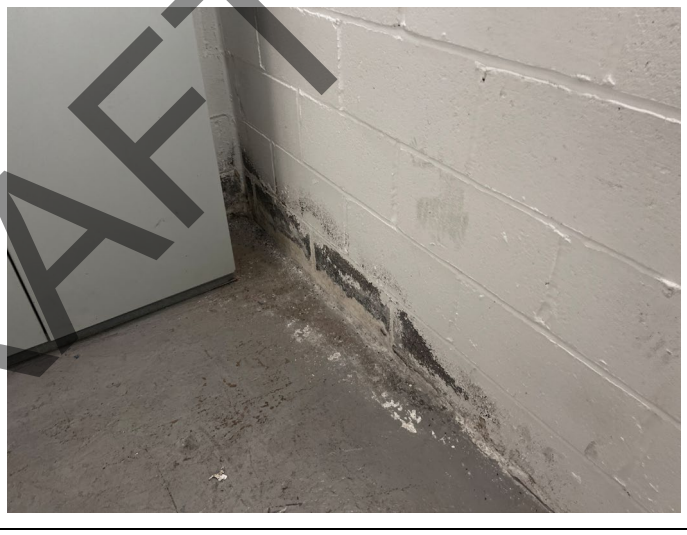
| 14. | Typical minor damage to decorations of back of house area, level -2. | |

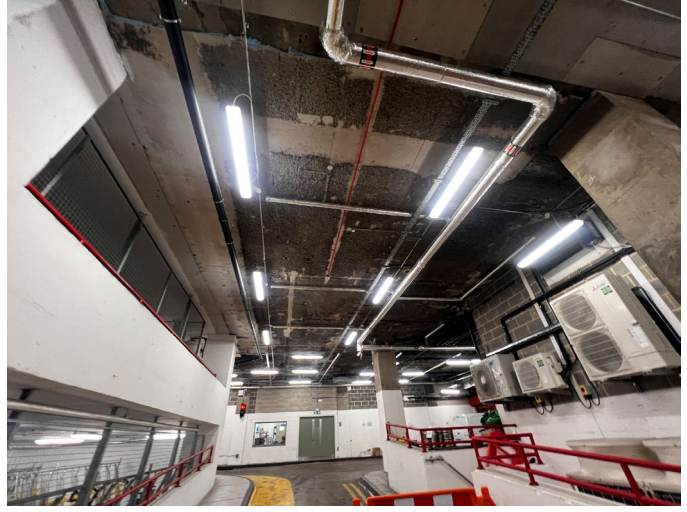
| 15. | Sprayed concrete soffit to loading bay which is damaged in areas. The Fire Risk Assessment should advise if repairs are required (i). | |

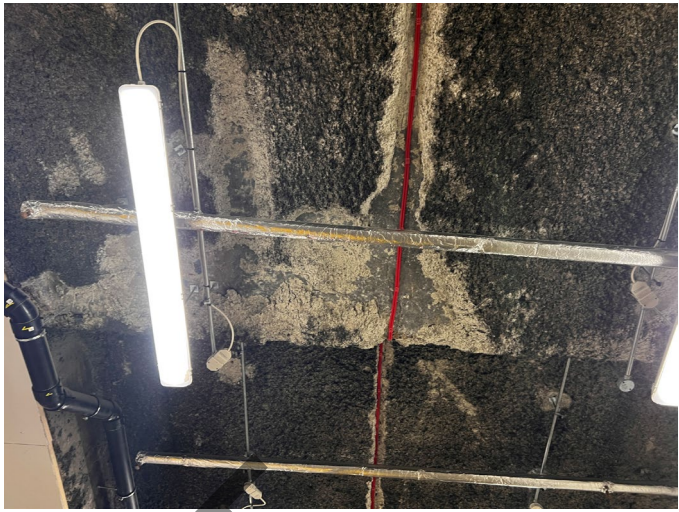
| 16. | Sprayed concrete soffit to loading bay which is damaged in areas. The Fire Risk Assessment should advise if repairs are required (ii). | |

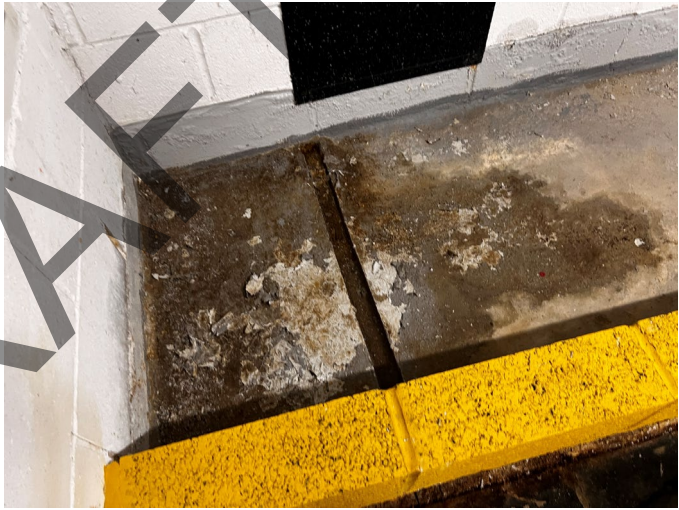
- We were advised of water ingress to various areas within basement level -3 that is being managed. In particular, the water tank room, boiler room, LV switch room, life safety switch room, generator room, and chiller room. Minor low level water damage to decorations is also evident to various areas of level -2. This is not affecting business operations. A drained cavity system has been used and water is collecting in the said cavity, which is subsequently not draining correctly and therefore is damaging the internal blockwork finishes as the water builds up. Bunds have been added to manage the water that seeps into the plant rooms. It is unclear where the drainage channels are connected and the condition or otherwise of the pumps and sumps. However, the system will presumably date back to base build and a maintenance inspection regime should be undertaken annually. A basement leak tracker should also be maintained.

| 17. | Bunding to level -3 where water is seeping out via drained cavity. | |

- 1) Undertake a Planned Preventative Maintenance programme that includes fabric.
- 2) Maintain basement leak tracker.

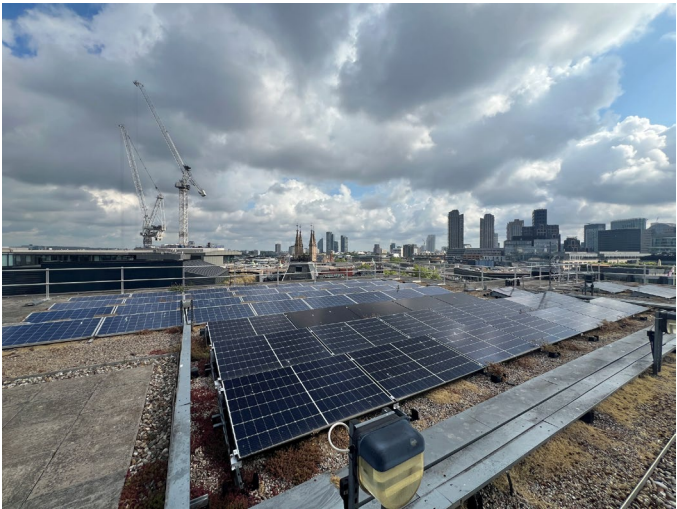
- The PV solar panels are operational and at the time of the inspection were generating 9.89 kW. However, output was noted to be relatively low, noting that weather conditions were cloudy at the time of inspection. It is recommended that the panels are cleaned to improve performance. Subject to continued routine maintenance, the system is expected to remain serviceable throughout the period covered by this report.

| 16. | PV solar panels. | |

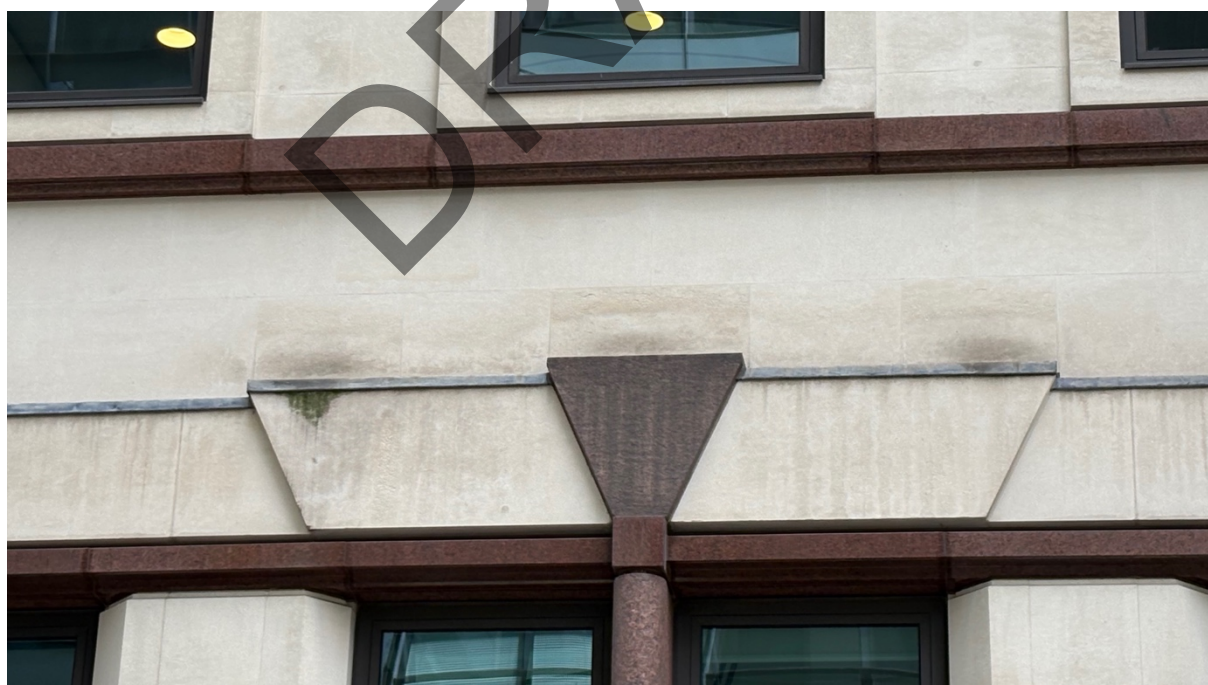
- 4.10 The original and 2017 installed stonework generally appears to be in a satisfactory condition however there are a small number of areas of dark staining that may be a consequence of dampness. Accordingly a budget sum should be included within any planned maintenance schedule in the event that repairs are required.
- 4.11 No remedial repair work is required in excess of normal maintenance for the next ten years.
- 4.12 Normal maintenance work is considered to include the repair of (a) any localised rainwater ingress and (b) replacement of any misted or shattered double glazed units should either occur in the future.
- 4.13 It is recommended as desirable that a specialist chemical restorative clean be undertaken to all metal finishes and the stonework for the sole purpose of improving the visual appearance.

**Photograph 14 – Localised damp and algae staining to the original stonework.**

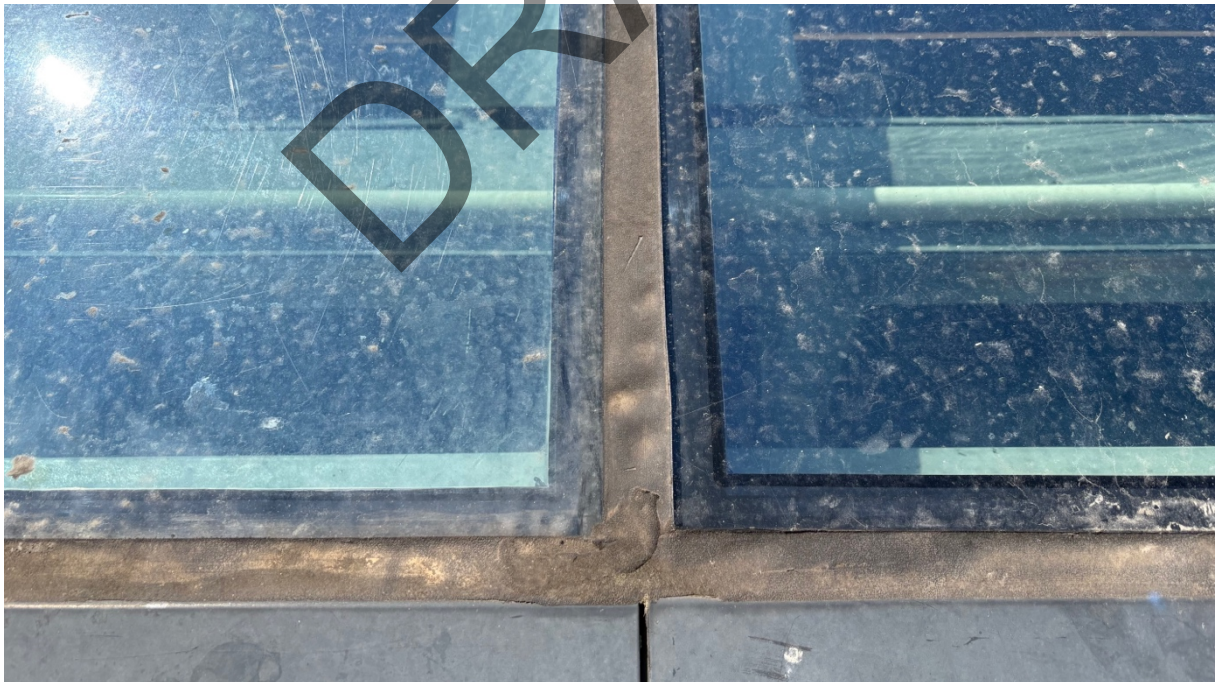
**Photograph 18 – Close of the atrium roof silicone seals in a satisfactory condition.**

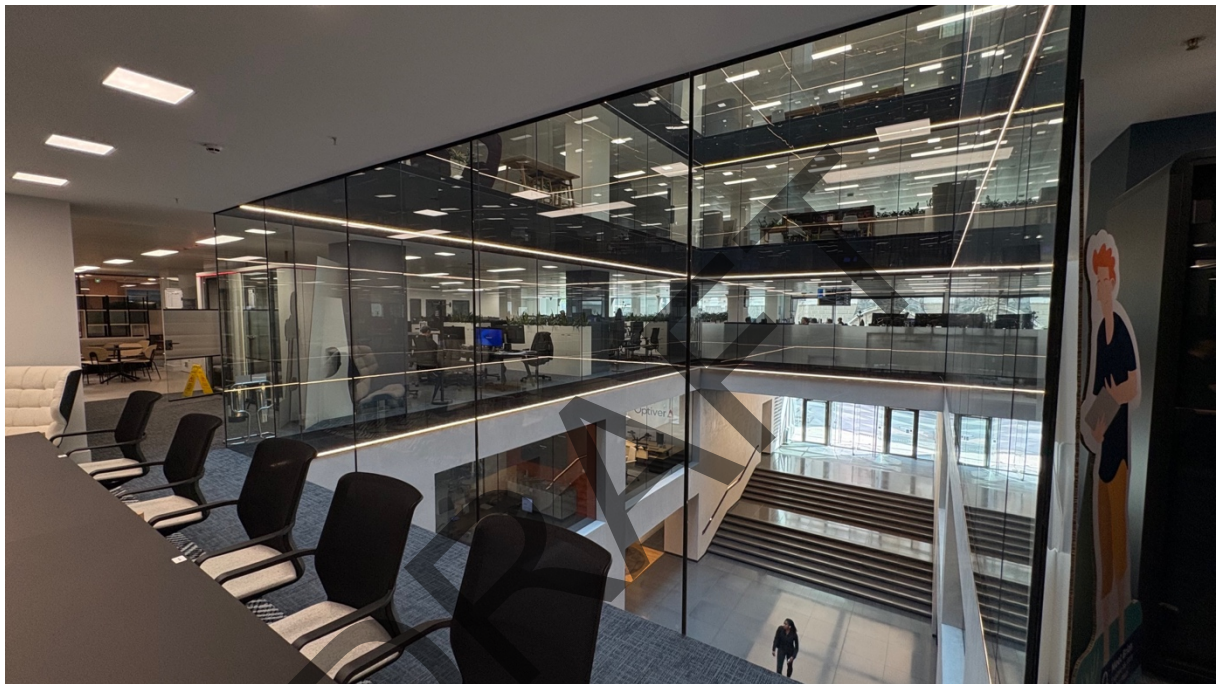
- *Whilst there are no widespread uses of toughened glass within the external facades, it has been used to form the internal atrium walls where two panes of wall glazing have previously failed as an anticipated consequence of a nickel sulphide inclusion.*

Photograph 21 – Internal atrium wall at Level 2.
