Vendor's building survey report

## Twenty Old Bailey, London EC4M 7AN

Prepared for: Hines UK Ltd  
Prepared by: Simon Devlin BSc (Hons) MRICS  
Viki Tsoutsas MEng MSc  
Issue date: 03 June 2026  
Report stage: Draft  
Reference: 133500-100

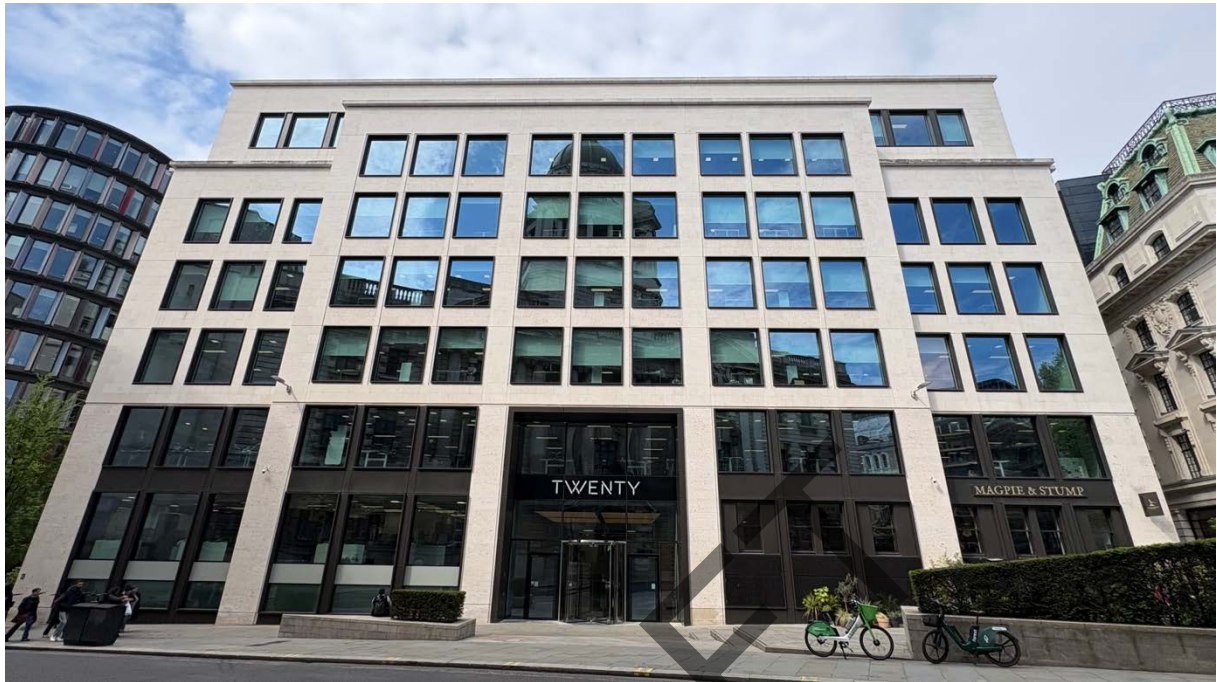
Photograph 1 – General view of the front east elevation constructed in 2017.

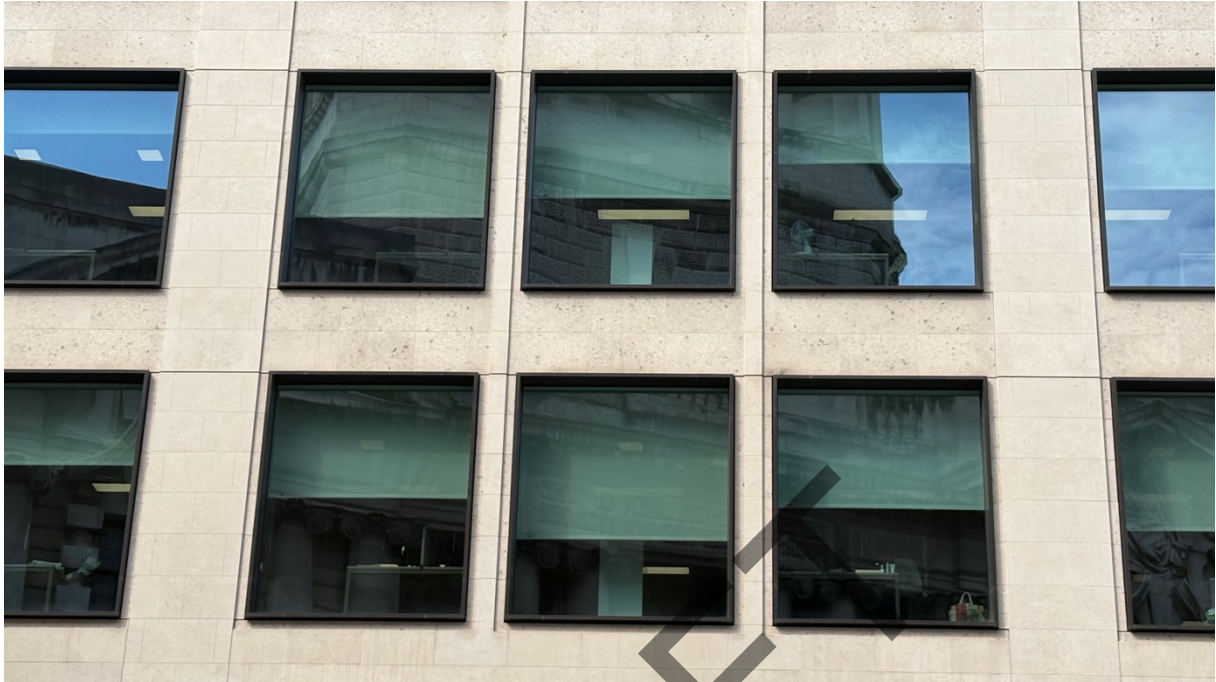
**Photograph 3 – Front elevation showing the 2017 installed windows and Moleanos stonework.**

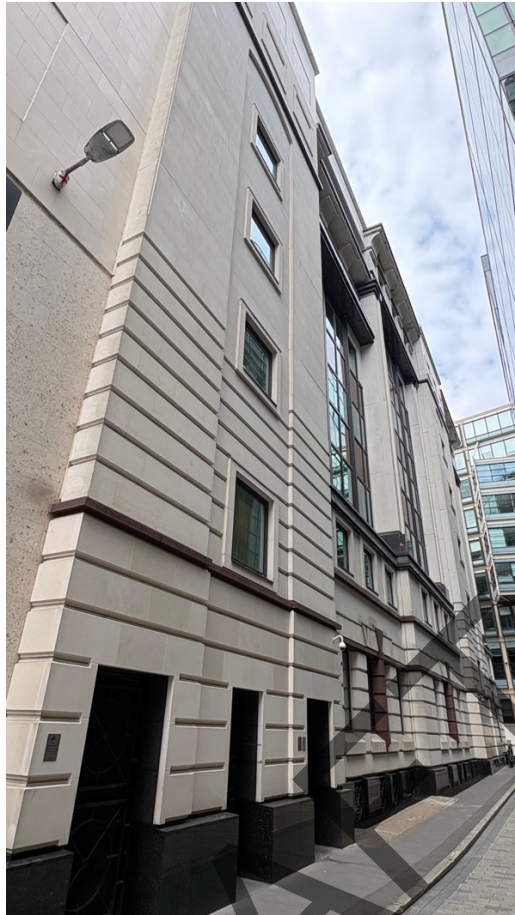
**Photograph 5 – North elevation.**  
(2017 stonework on the left and original stonework on the right)

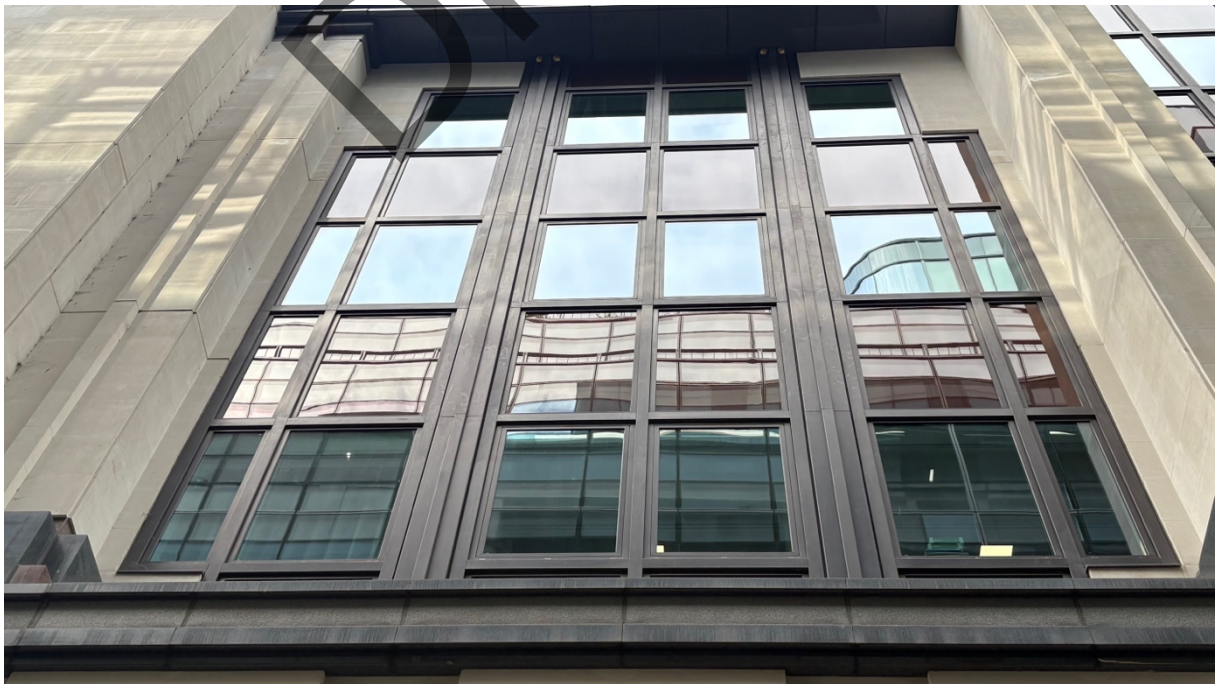
**Photograph 6 – North elevation showing original infill area of curtain walling.**

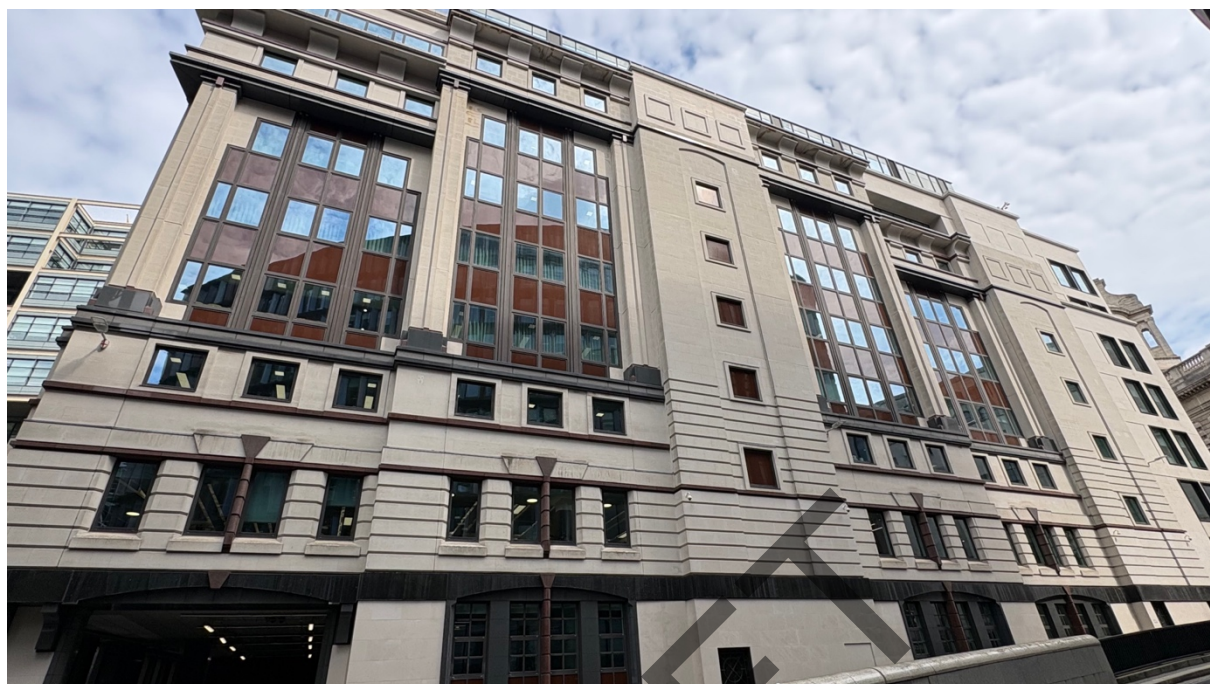
**Photograph 7 – General view of the south elevation.**

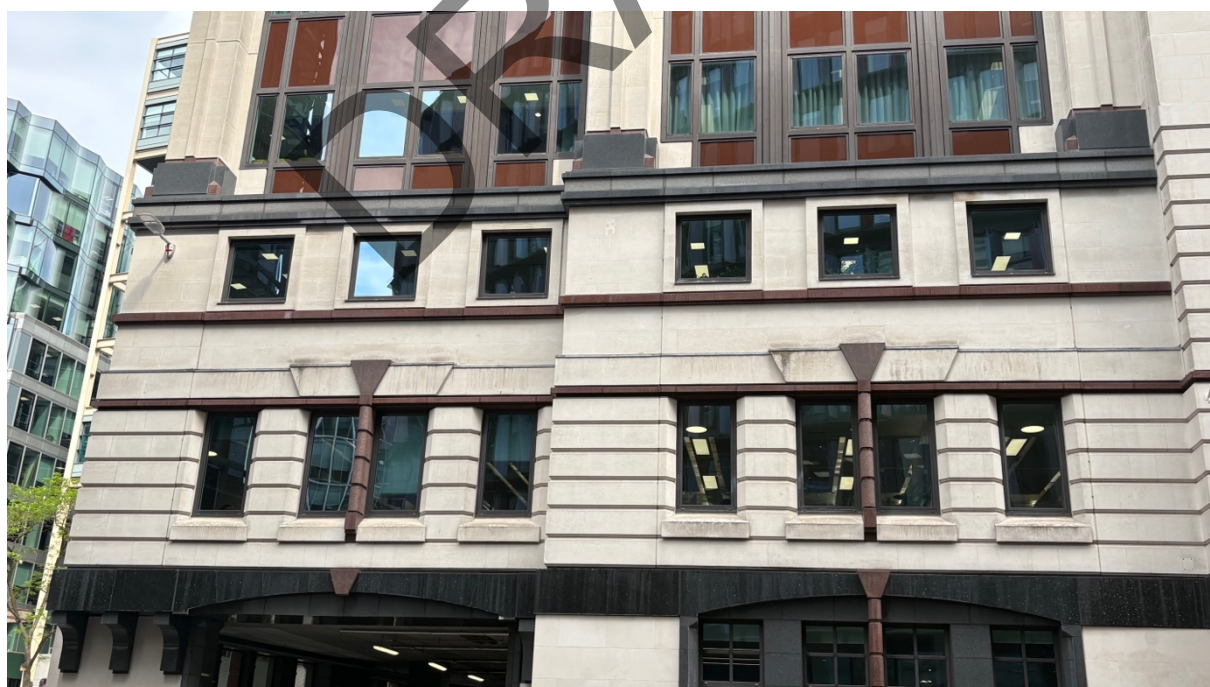
**Photograph 8 – Part view of the south elevation showing the original stonework and windows.**

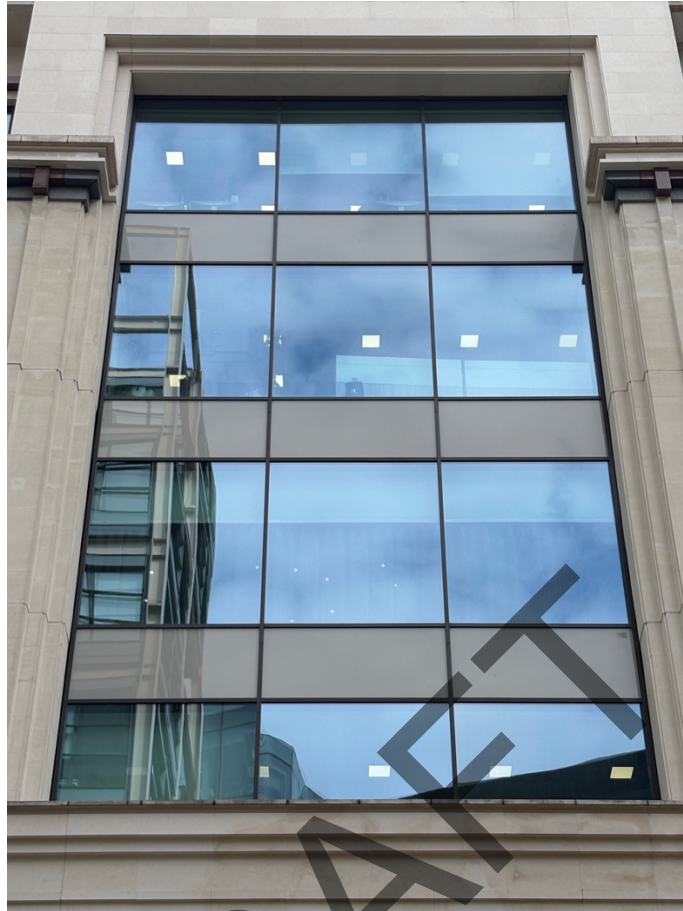
**Photograph 11 – West elevation 2017 curtain wall over entrance.**

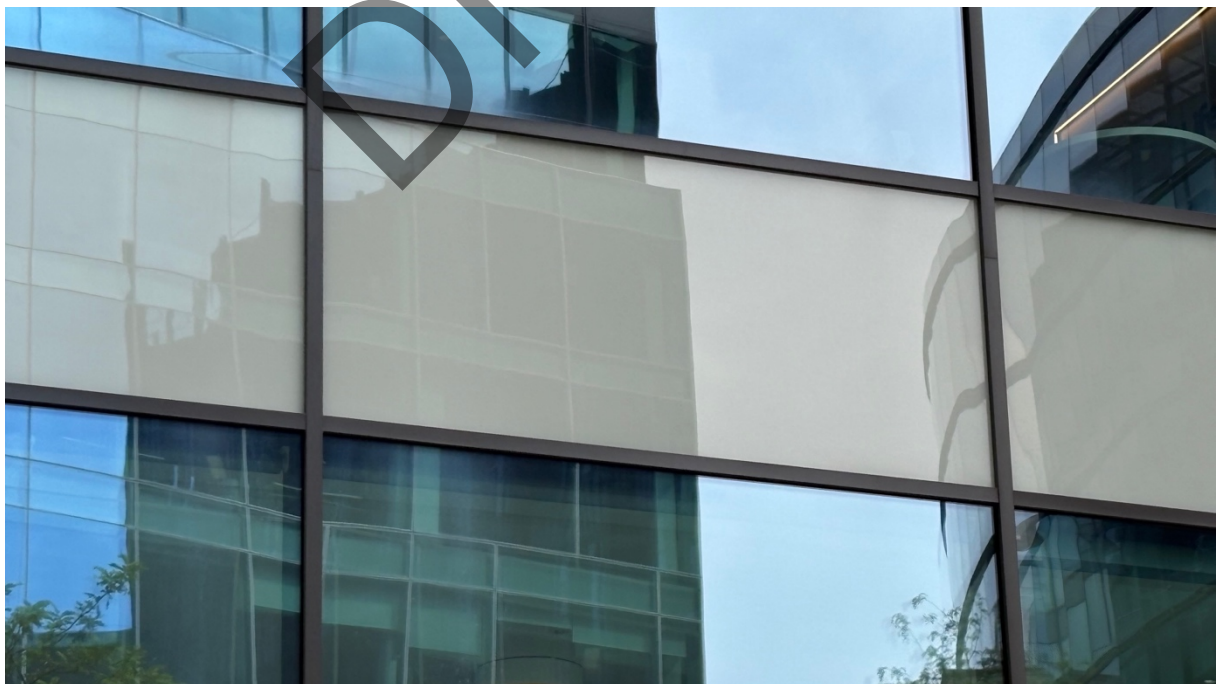
**Photograph 12 – Glazed spandrel panel within the curtain wall as above.**

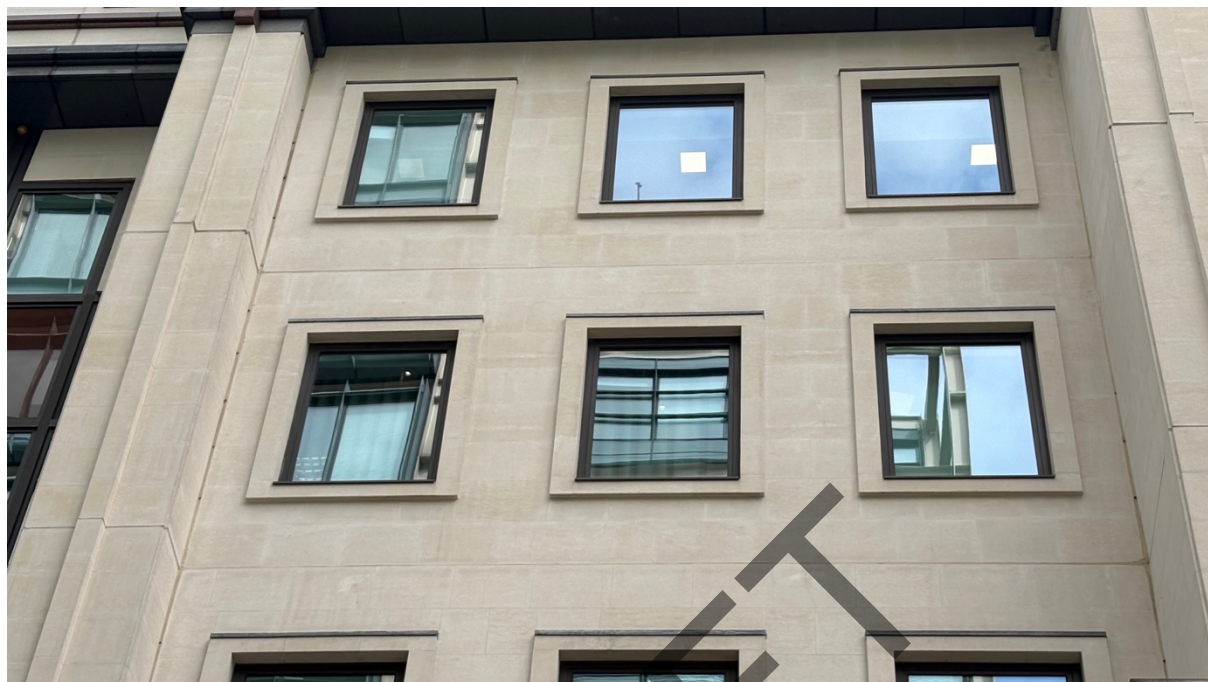
**Photograph 13 – Rear west elevation showing the original stonework and windows.**

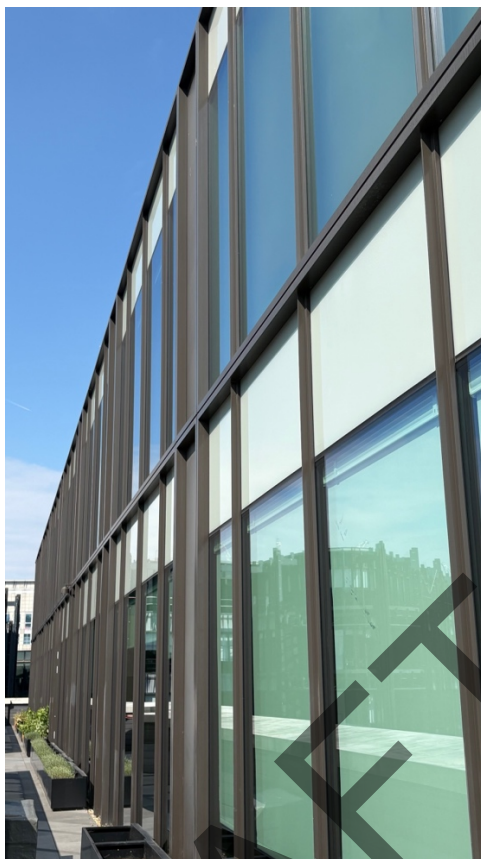
**Photograph 15 – 2017 installed curtain wall at Level 8 & 9.**

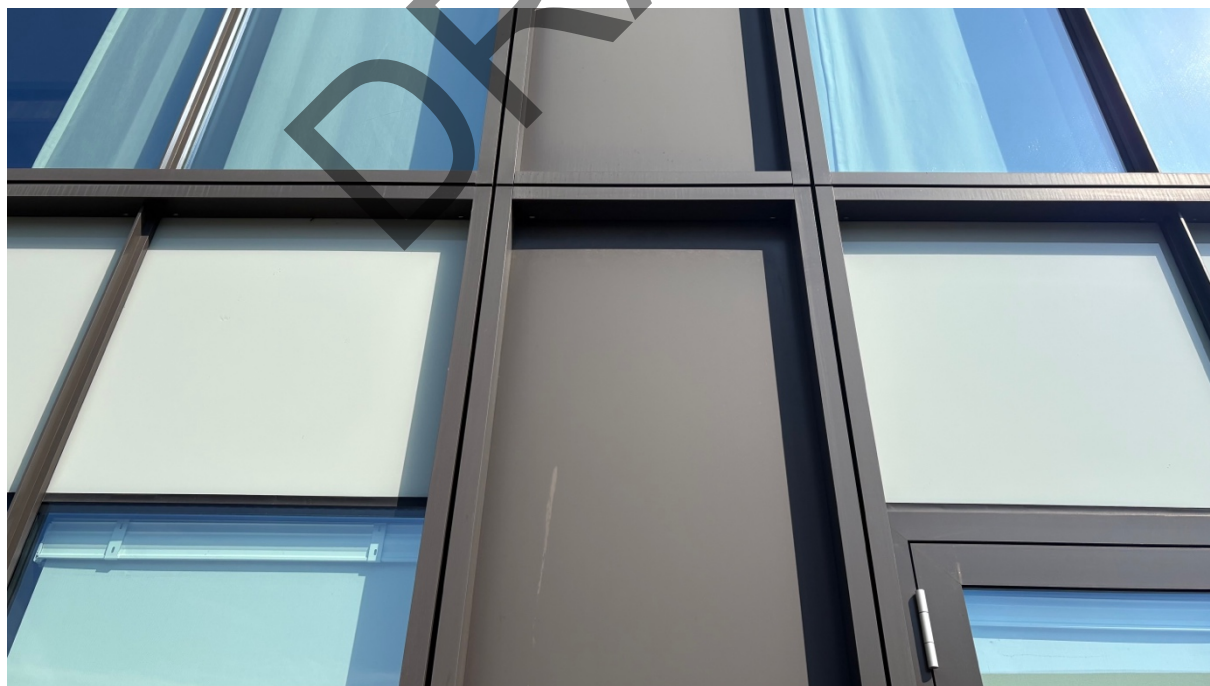
**Photograph 16 – Close view of the 2017 installed curtain wall at Level 8 & 9.**

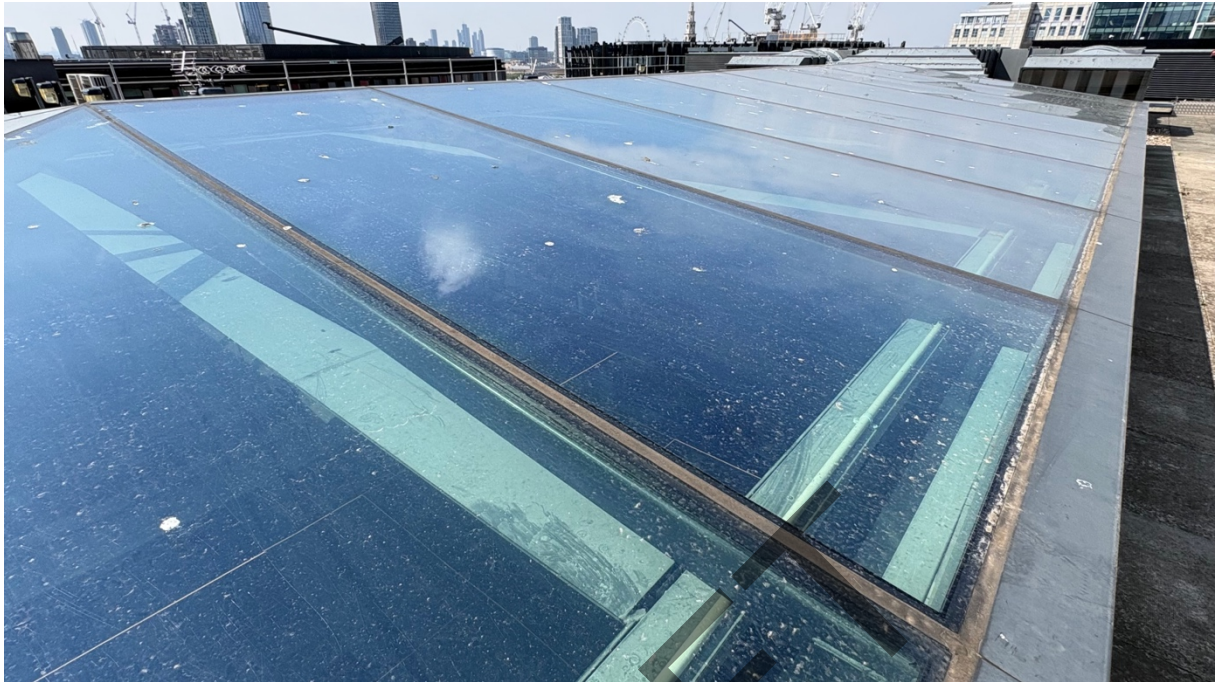
**Photograph 17 – General view of the glazed atrium roof.**

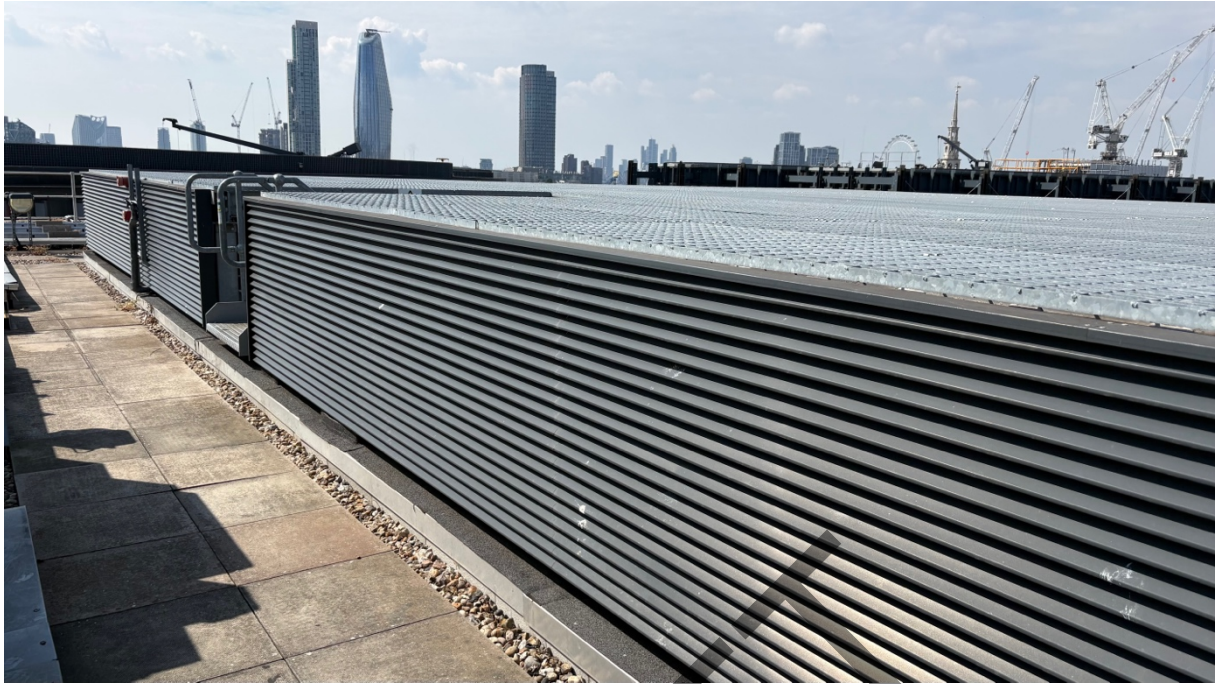
**Photograph 19 - General view of the louvre blade open plant enclosure at roof level.**
