Vendor's building survey report

## Twenty Old Bailey, London EC4M 7AN

Prepared for: Hines UK Ltd  
Prepared by: Simon Devlin BSc (Hons) MRICS  
Viki Tsoutsas MEng MSc  
Issue date: 03 June 2026  
Report stage: Draft  
Reference: 133500-100

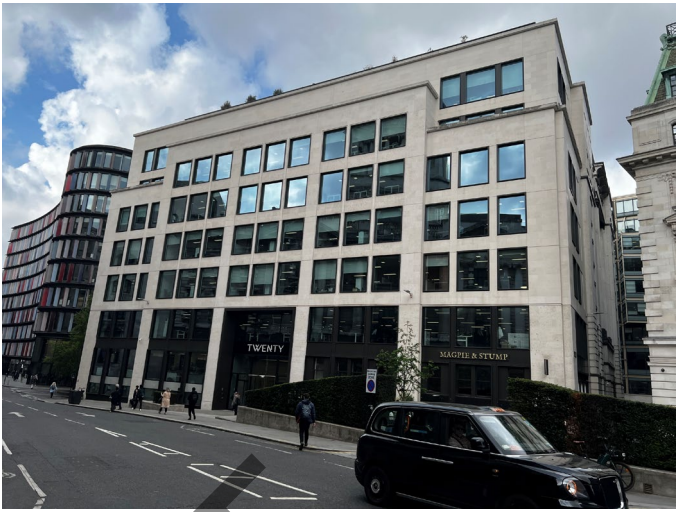
| 1. | Front elevation on Old Bailey (East). | |

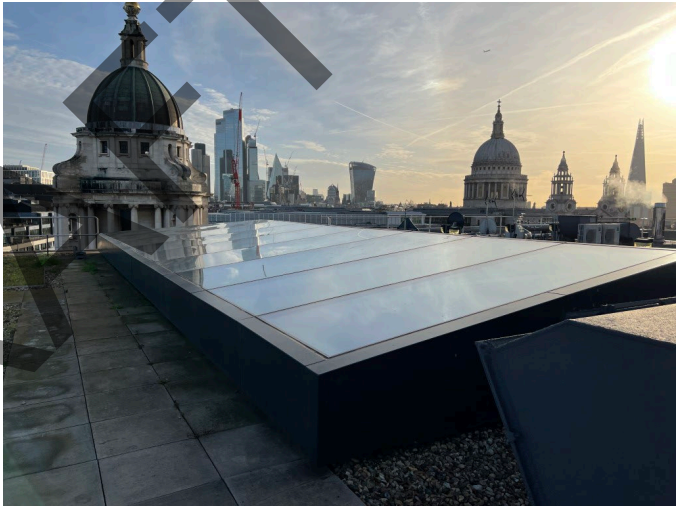
| 8. | Atrium rooflight. | |

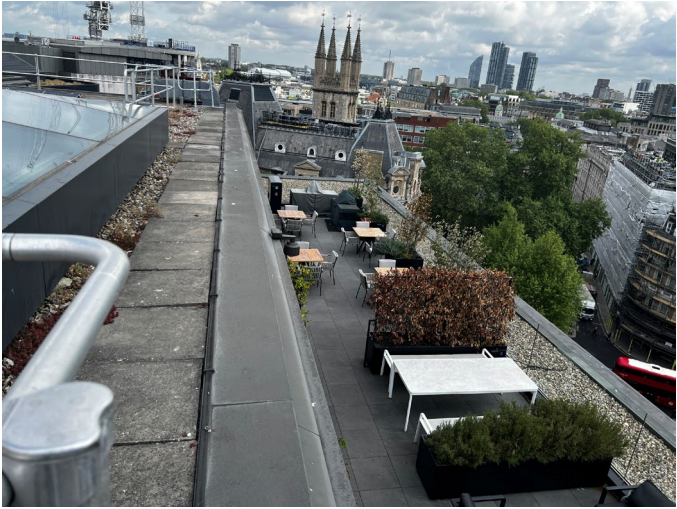
| 9. | Terrace to 9 <sup>th</sup> floor as viewed from main roof. | |

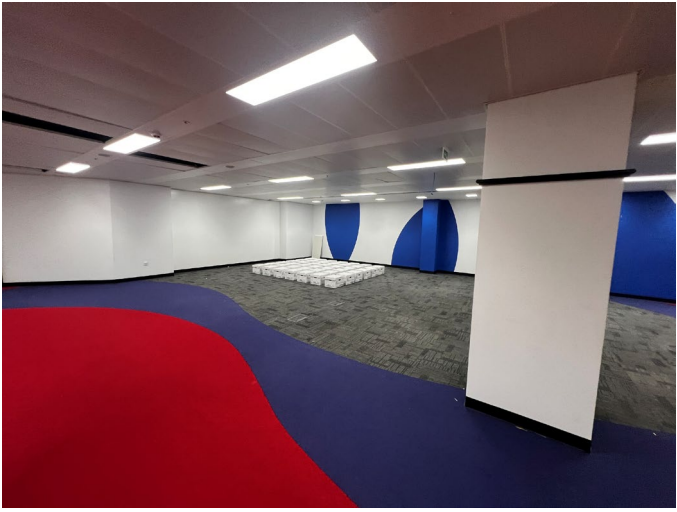
| 12. | The part lower ground floor (north) is empty but is still let by Metro Bank Plc. | |

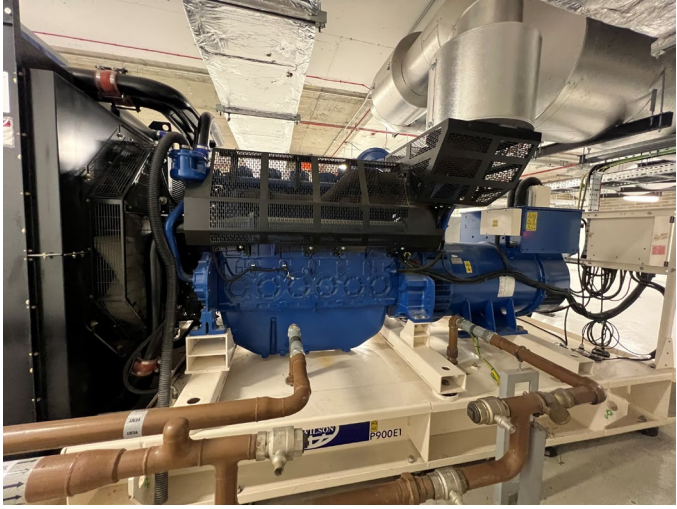
| 15. | Diesel generator. | |

- 2.3.1. No USTs were observed during the site walkover.
- 2.3.2. One diesel generator was observed within a bund at basement level. A diesel day tank of 1,380 litre capacity was attached to the generator. No hydrocarbon staining was observed within the bund or upon the supporting good quality hardstanding.

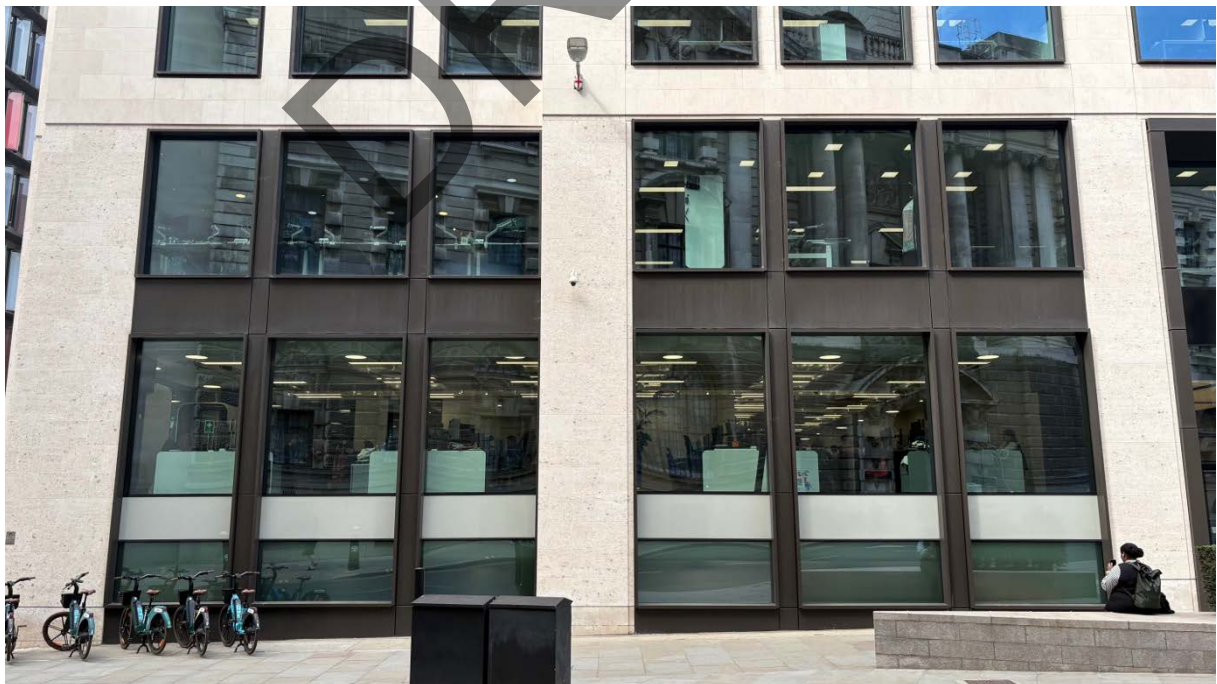
Photograph 2 – Front elevation showing the 2017 installed infill curtain walling.

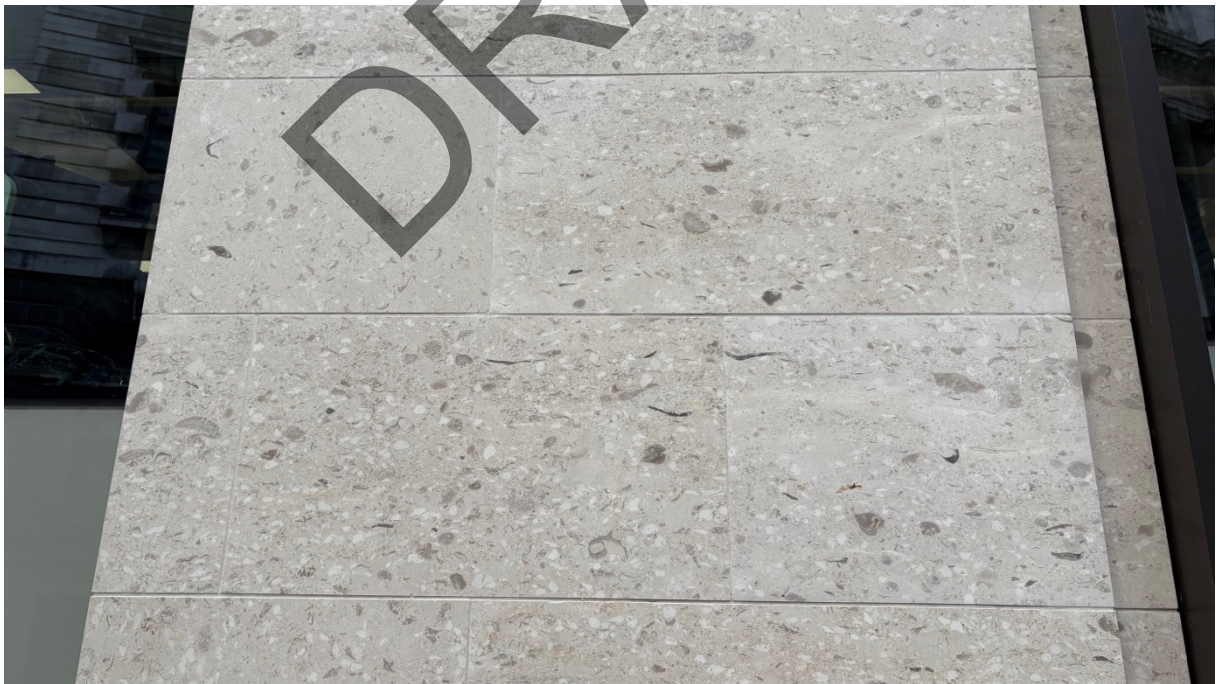
**Photograph 4 – Close view of the 2017 installed Moleanos stonework in a satisfactory condition.**

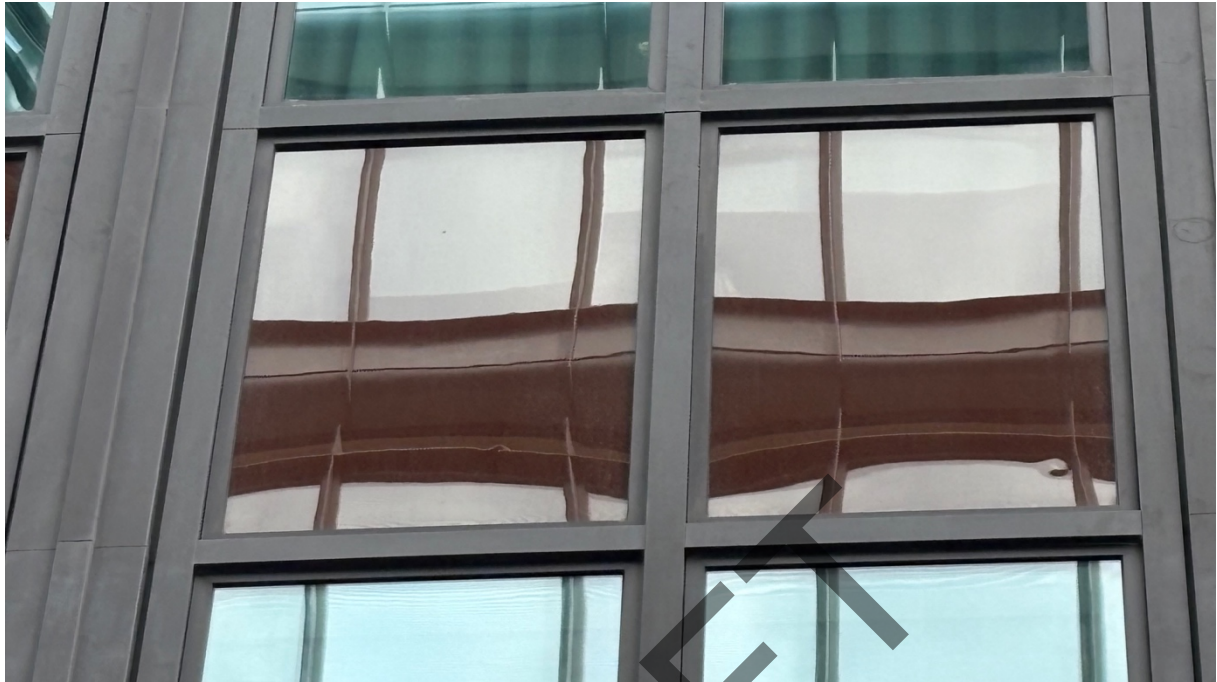
- 4.5 Our assessment of the cladding construction revealed no uses of aluminium composite material [ACM's] or high pressure laminate [HPL] material.
- 4.6 Our assessment of the cladding construction as shown in the O & M Manuals revealed that the insulation behind the opaque glazed spandrel panels and the brown insulated metal panels within the 2017 installed windows and curtain walling is Celotex RS5000 which is of combustible PIR composition. The opaque glazed spandrel panels within the original windows are also anticipated to be insulated however the type and composition of any such insulation is unknown. Photographs 9, 12 and 16 in Appendix A show typical examples. Details of the fire break detail where the spandrel panels cover the floor slab edge is also unknown.

**Photograph 9 – Original curtain walling spandrel panel at floor level.**

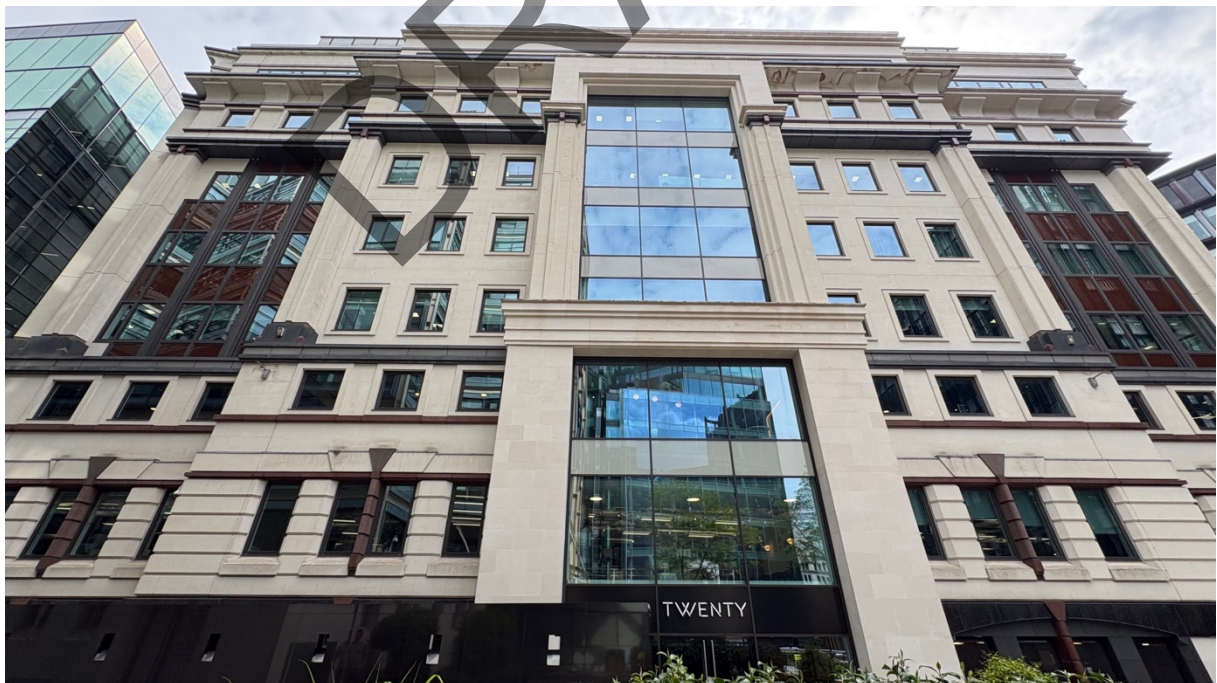
**Photograph 10 – General view of the rear west elevation which is mostly original other than new stonework, windows and curtain walling at high level.**

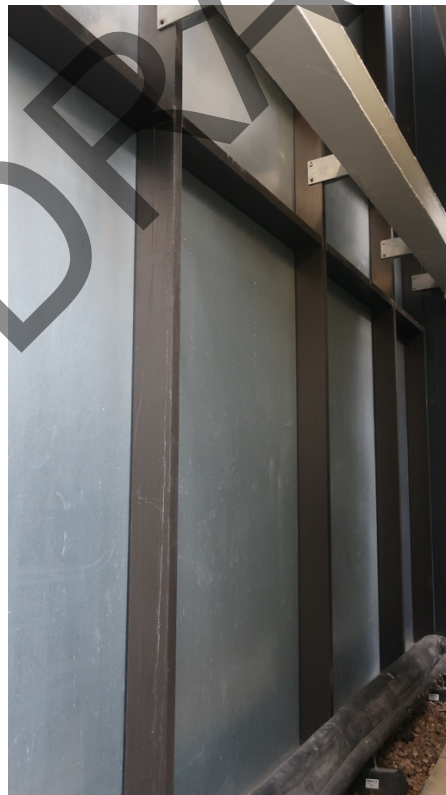
**Photograph 20 – The Rockspan composite panels to the plant enclosure are general inaccessible to view.**
